Manhole Inspection Summary

Manhole # S11O__017MH

Location Address: **3130 Frederick Ave**

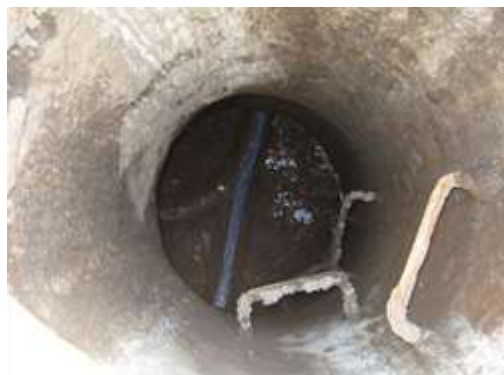
Top View

Infiltration from top

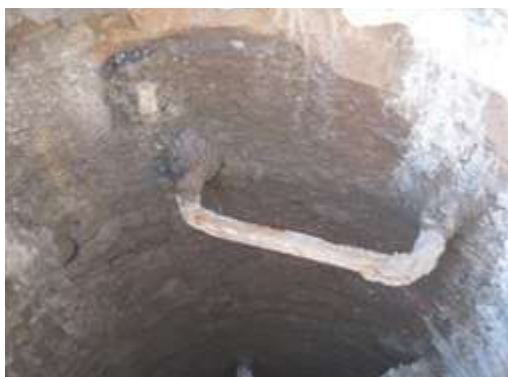
Defect 2

Corroded steps/infiltration in corbel

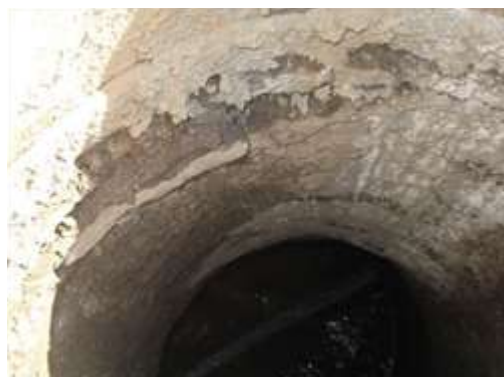
Defect 5

Sediment infiltration from top, wet infiltration along chimney and corbel walls

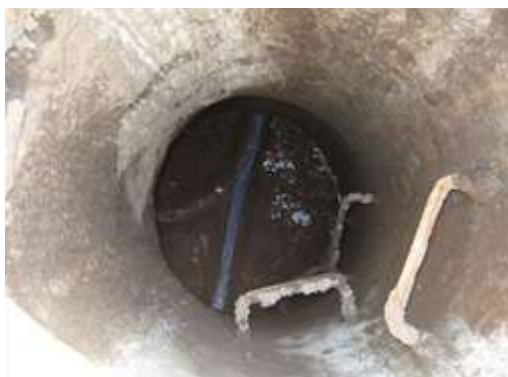
Defect 4

corroded steps

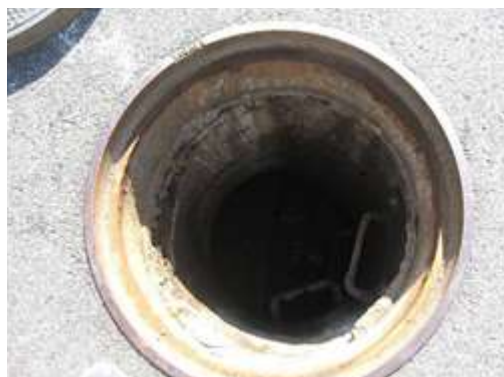
Defect 3

frame leaks

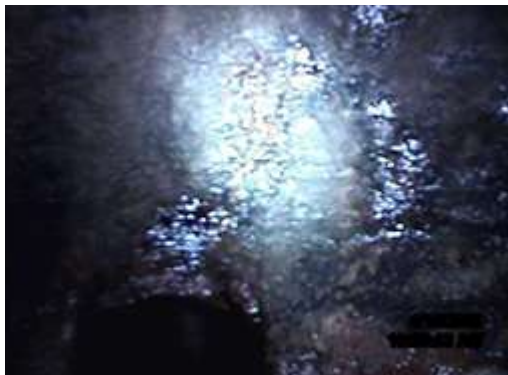
Defect 1

Active infiltration @ 12 position in Barrel

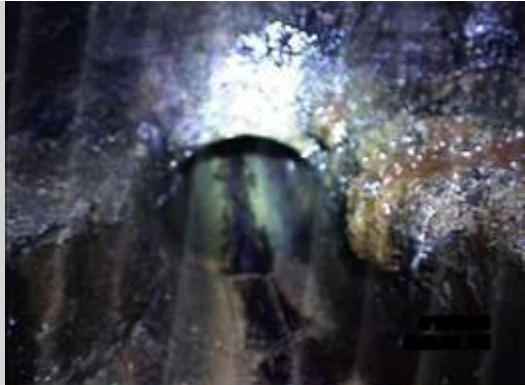
12 O'Clock Outflow

Pipe Height: **8.4** (in.) Rod and Bar (Angled)
Pipe Material: **Clay** ☐ Pipe Lined
Invert Depth: **11.35** (ft.) Flow Characteristics: **Fast**
Deposits: ☒ None ☐ Mud ☐ Sludge ☐ Debris ☐ Grease
Silt Depth: **0** (in.) Deposits Extent:
Infiltration: **Evidence** Pipe Seal Cond: **Unknown**

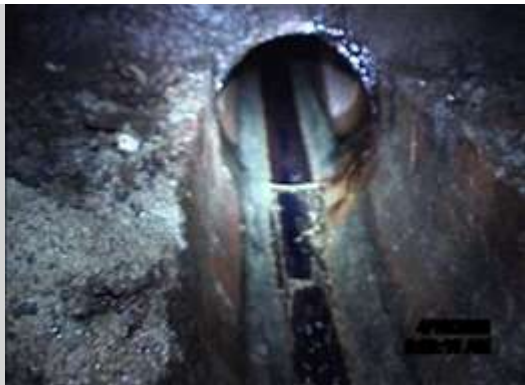
6 O'Clock Inflow

Pipe Height: **7.2** (in.) Rod and Bar (Angled)
Pipe Material: **Clay** ☐ Pipe Lined
Invert Depth: **10.75** (ft.) Flow Characteristics: **Fast**
Deposits: ☒ None ☐ Mud ☐ Sludge ☐ Debris ☐ Grease
Silt Depth: **0** (in.) Deposits Extent:
Infiltration: **Evidence** Pipe Seal Cond: **Unknown**

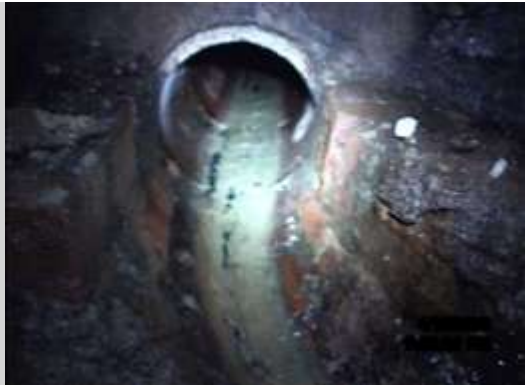
9 O'Clock Inflow

Infiltration: **Evidence** Pipe Seal Cond: **Unknown**

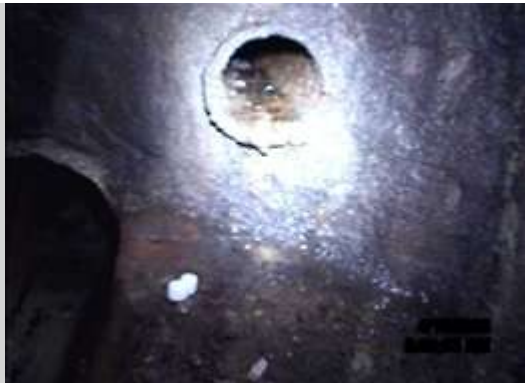
10 O'Clock Inflow

Infiltration: **Evidence** Pipe Seal Cond: **Unknown**
